Hurricane Maria: A Harbinger of Imperative Changes to Caribbean Structural Design and Construction

UNENGINEERED BUILDINGS (HOUSES)

HURRICANE MARIA DAMAGE ASSESSMENT

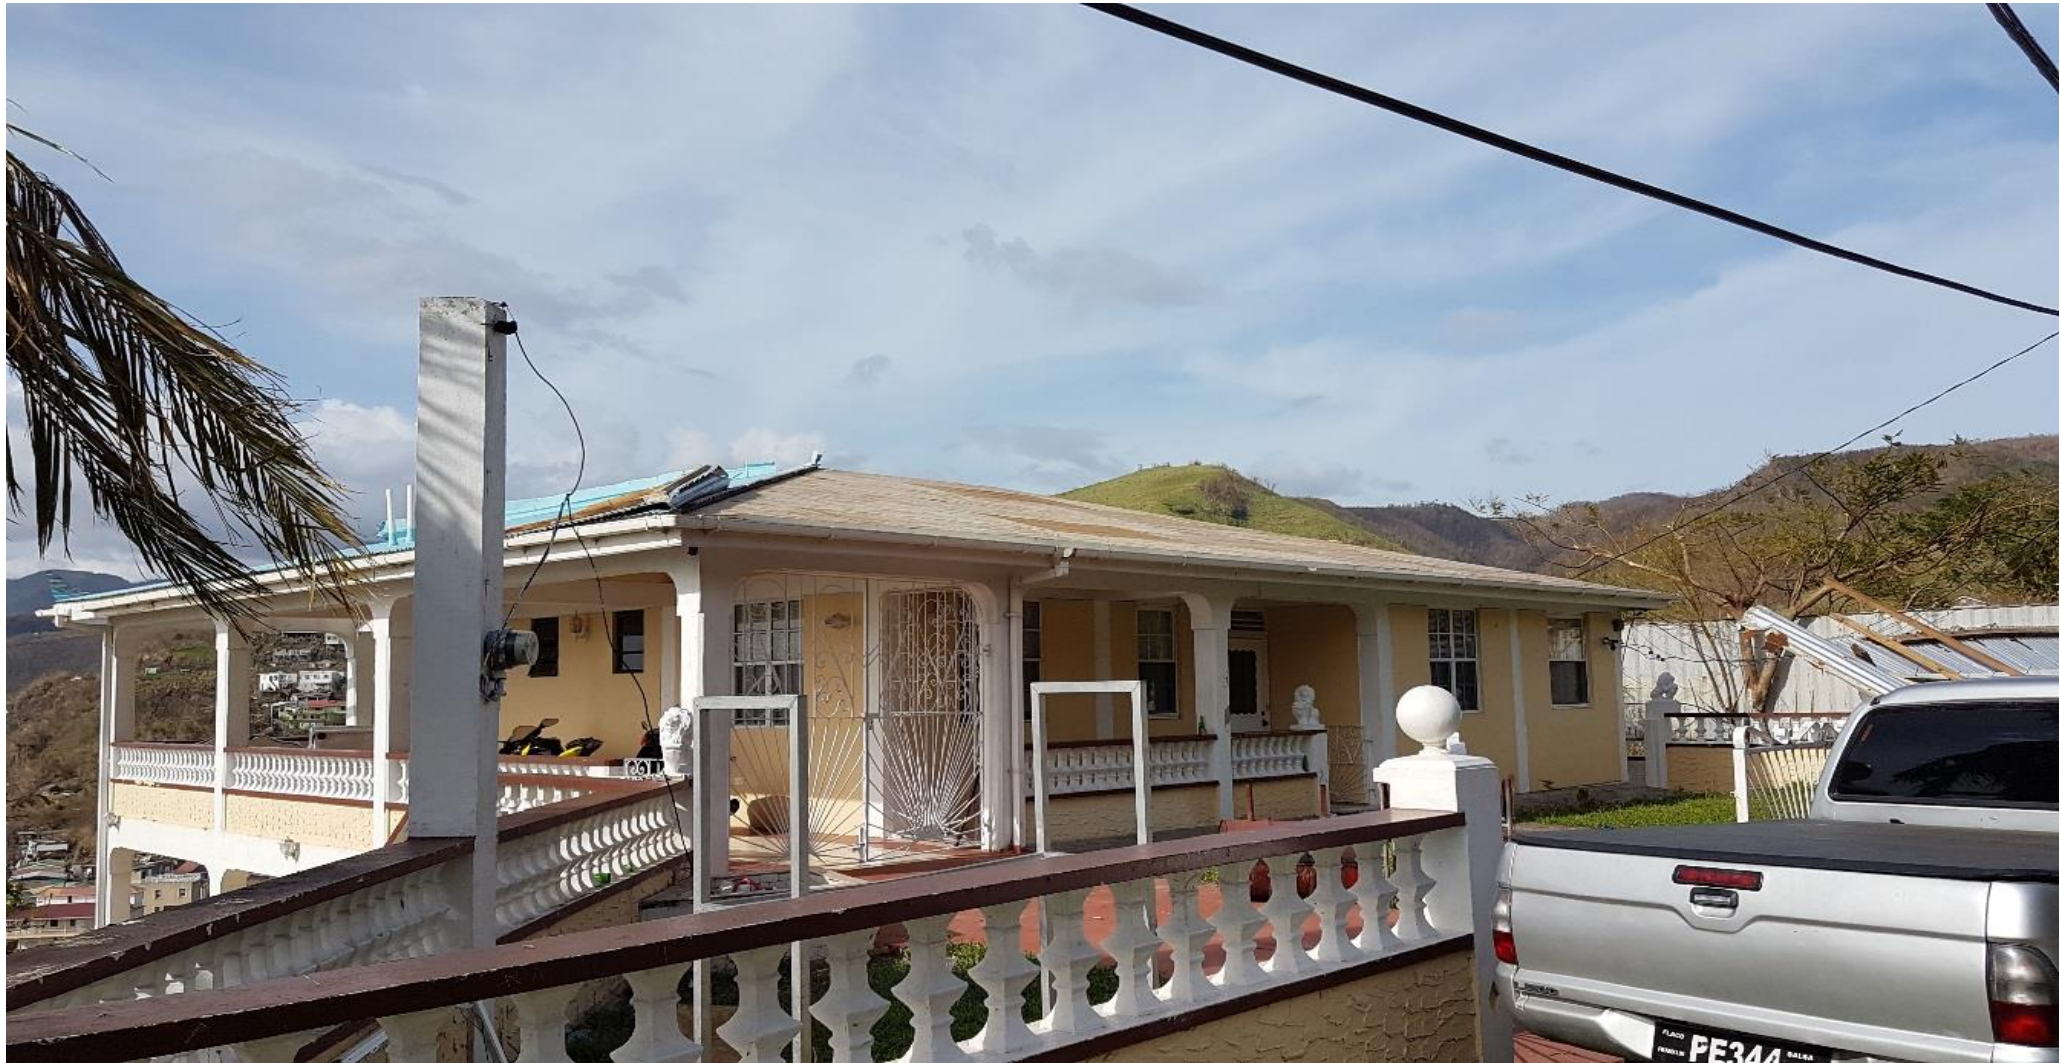
IMAGE 15 – TYPICAL ROOF DAMAGE – FASTENER PULLOUT AND SHEETING TEAROUT

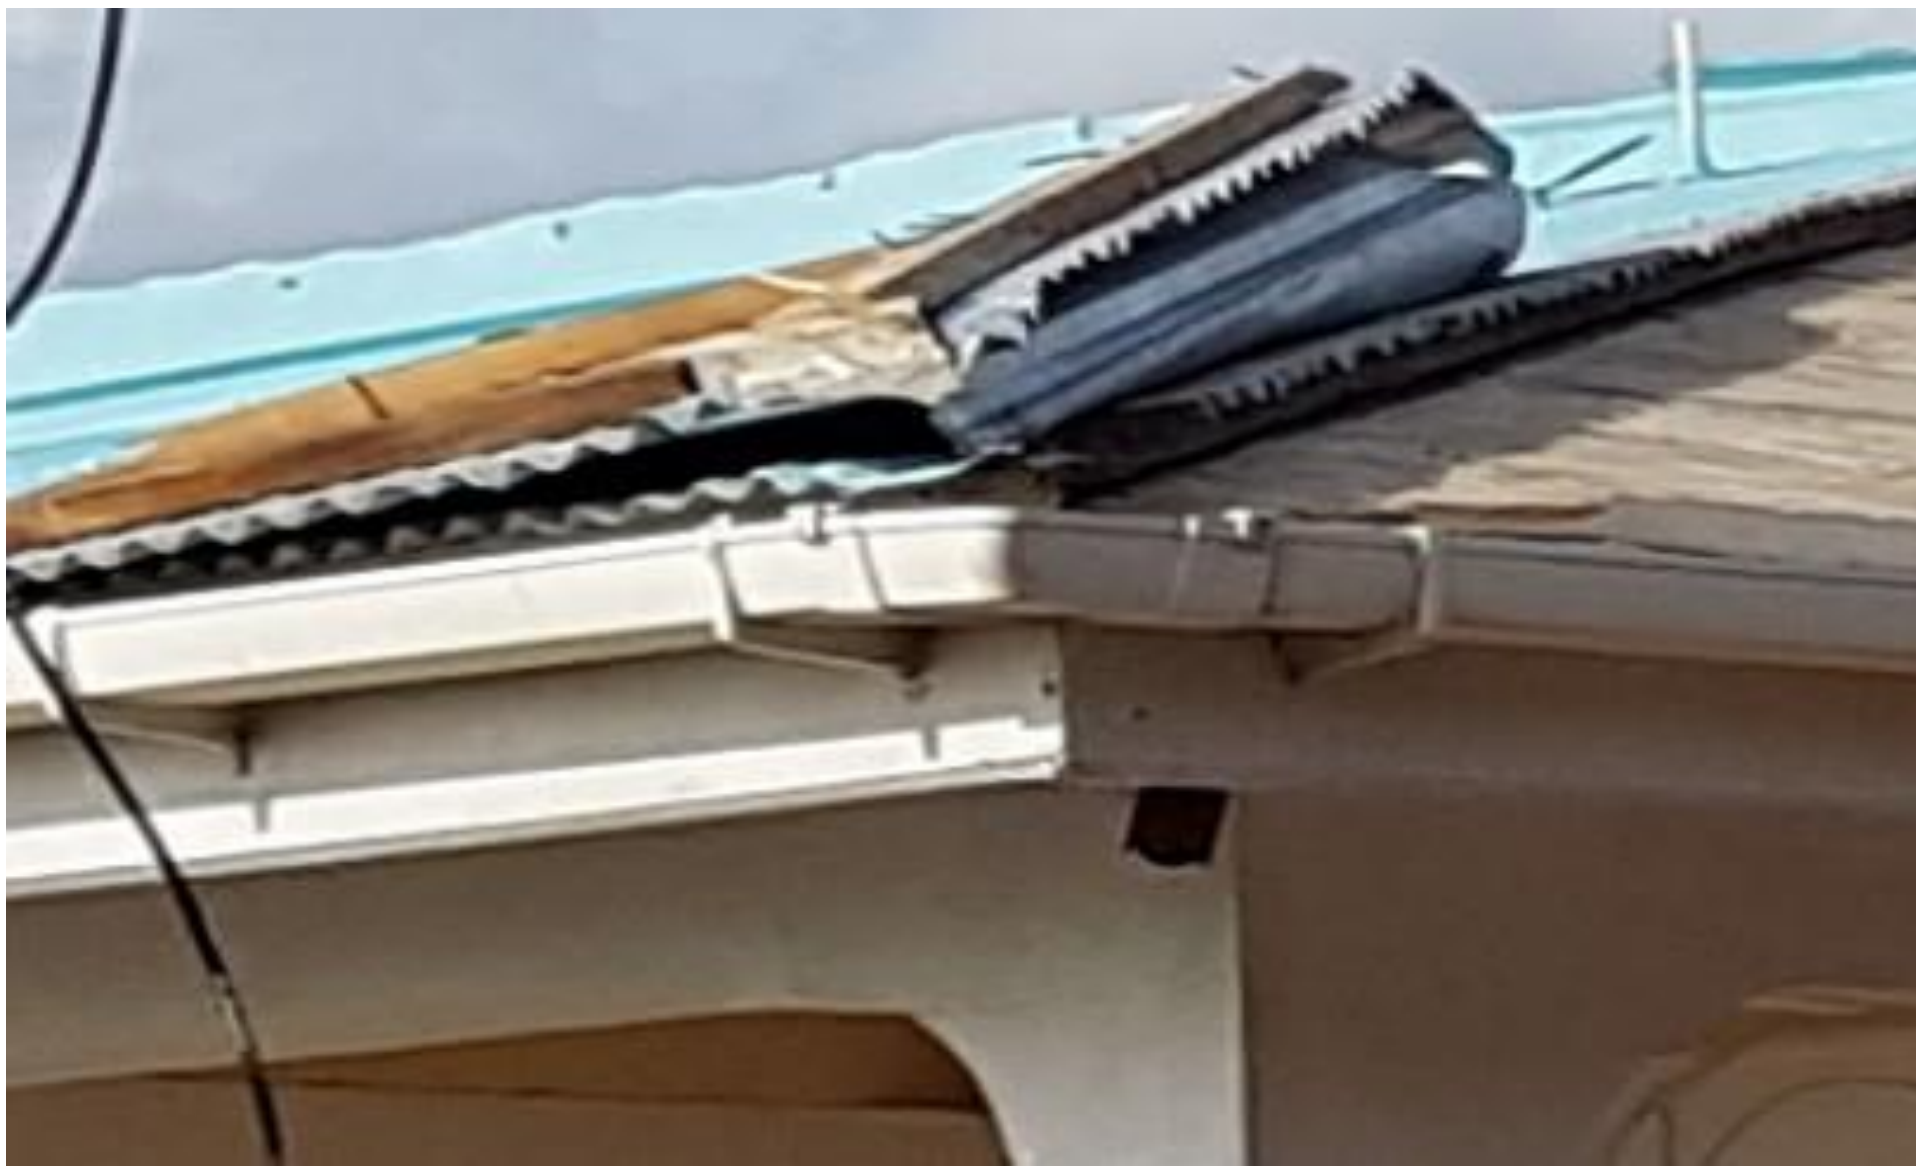
IMAGE 16 –EXAMPLE OF NAIL PULLOUT

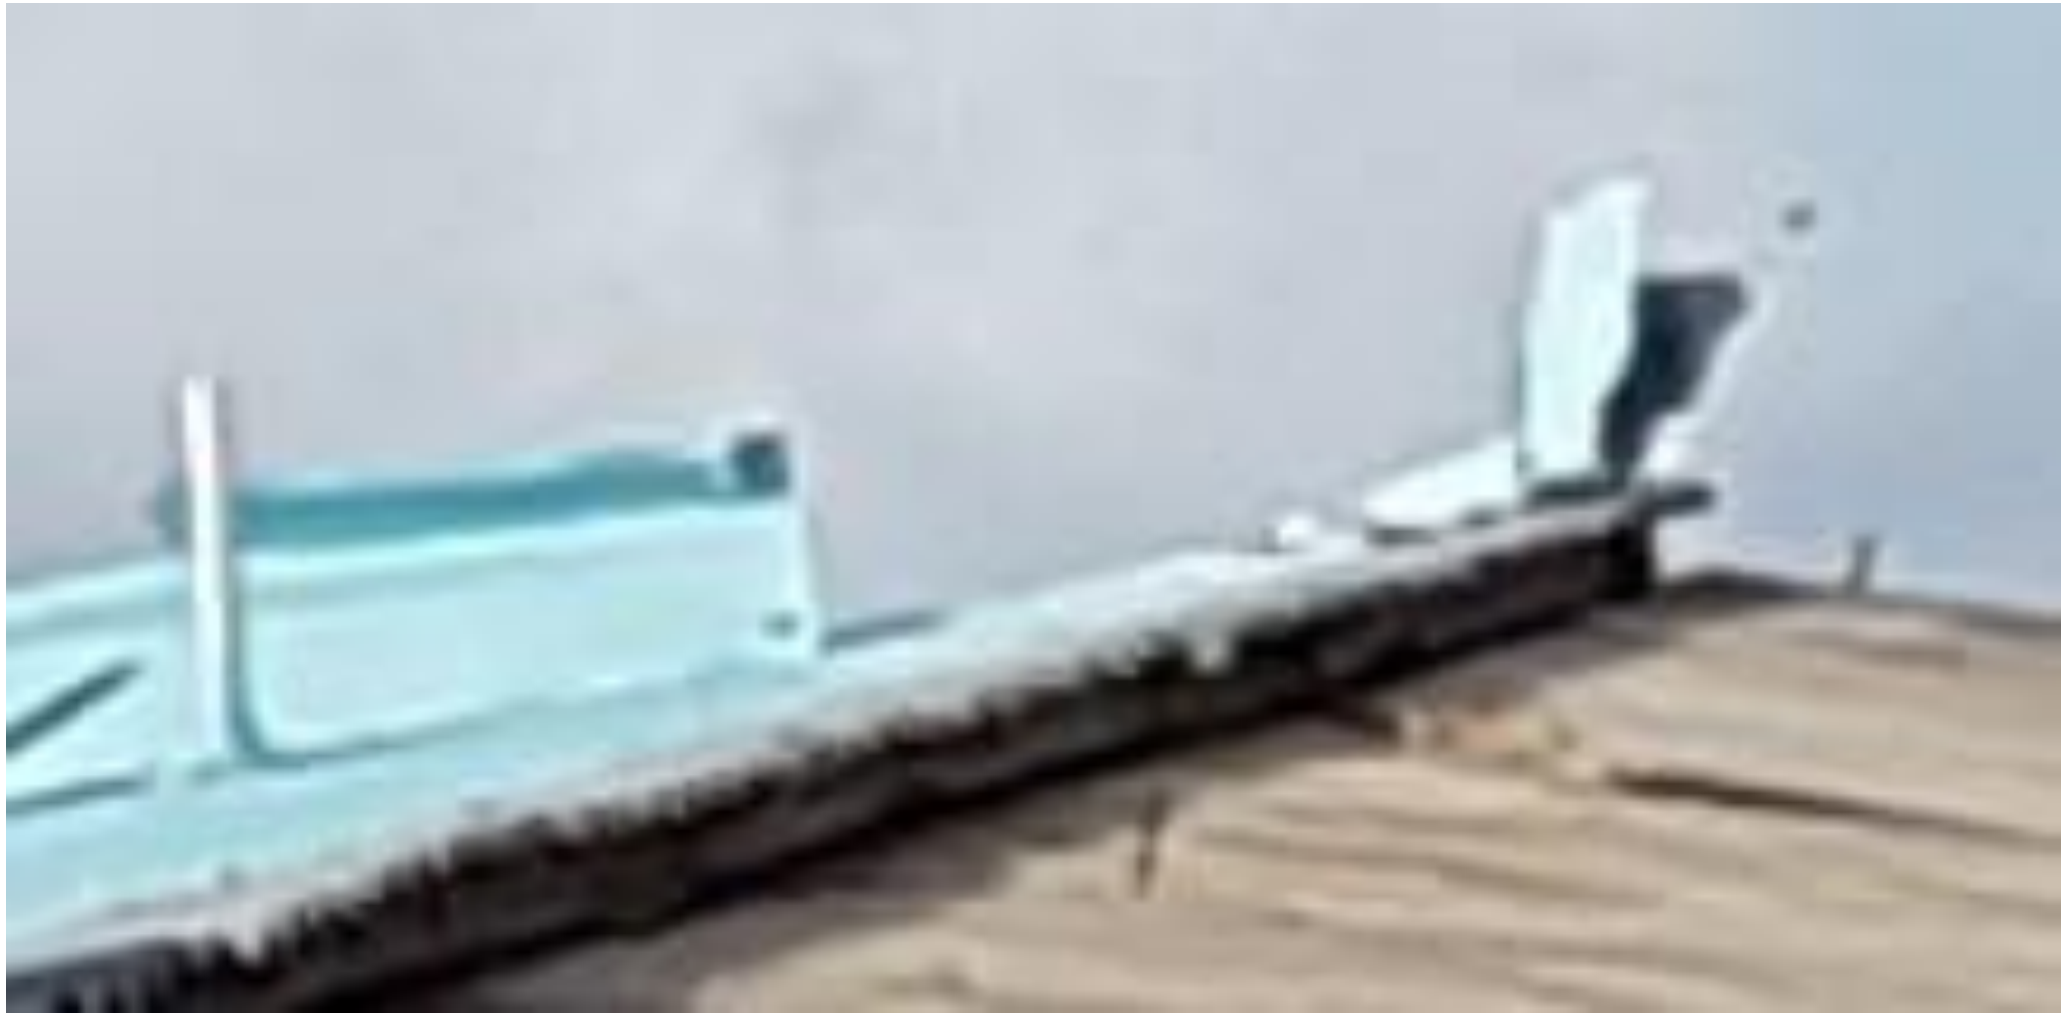
IMAGE 17 –EXAMPLE OF SHEETING TEAROUT

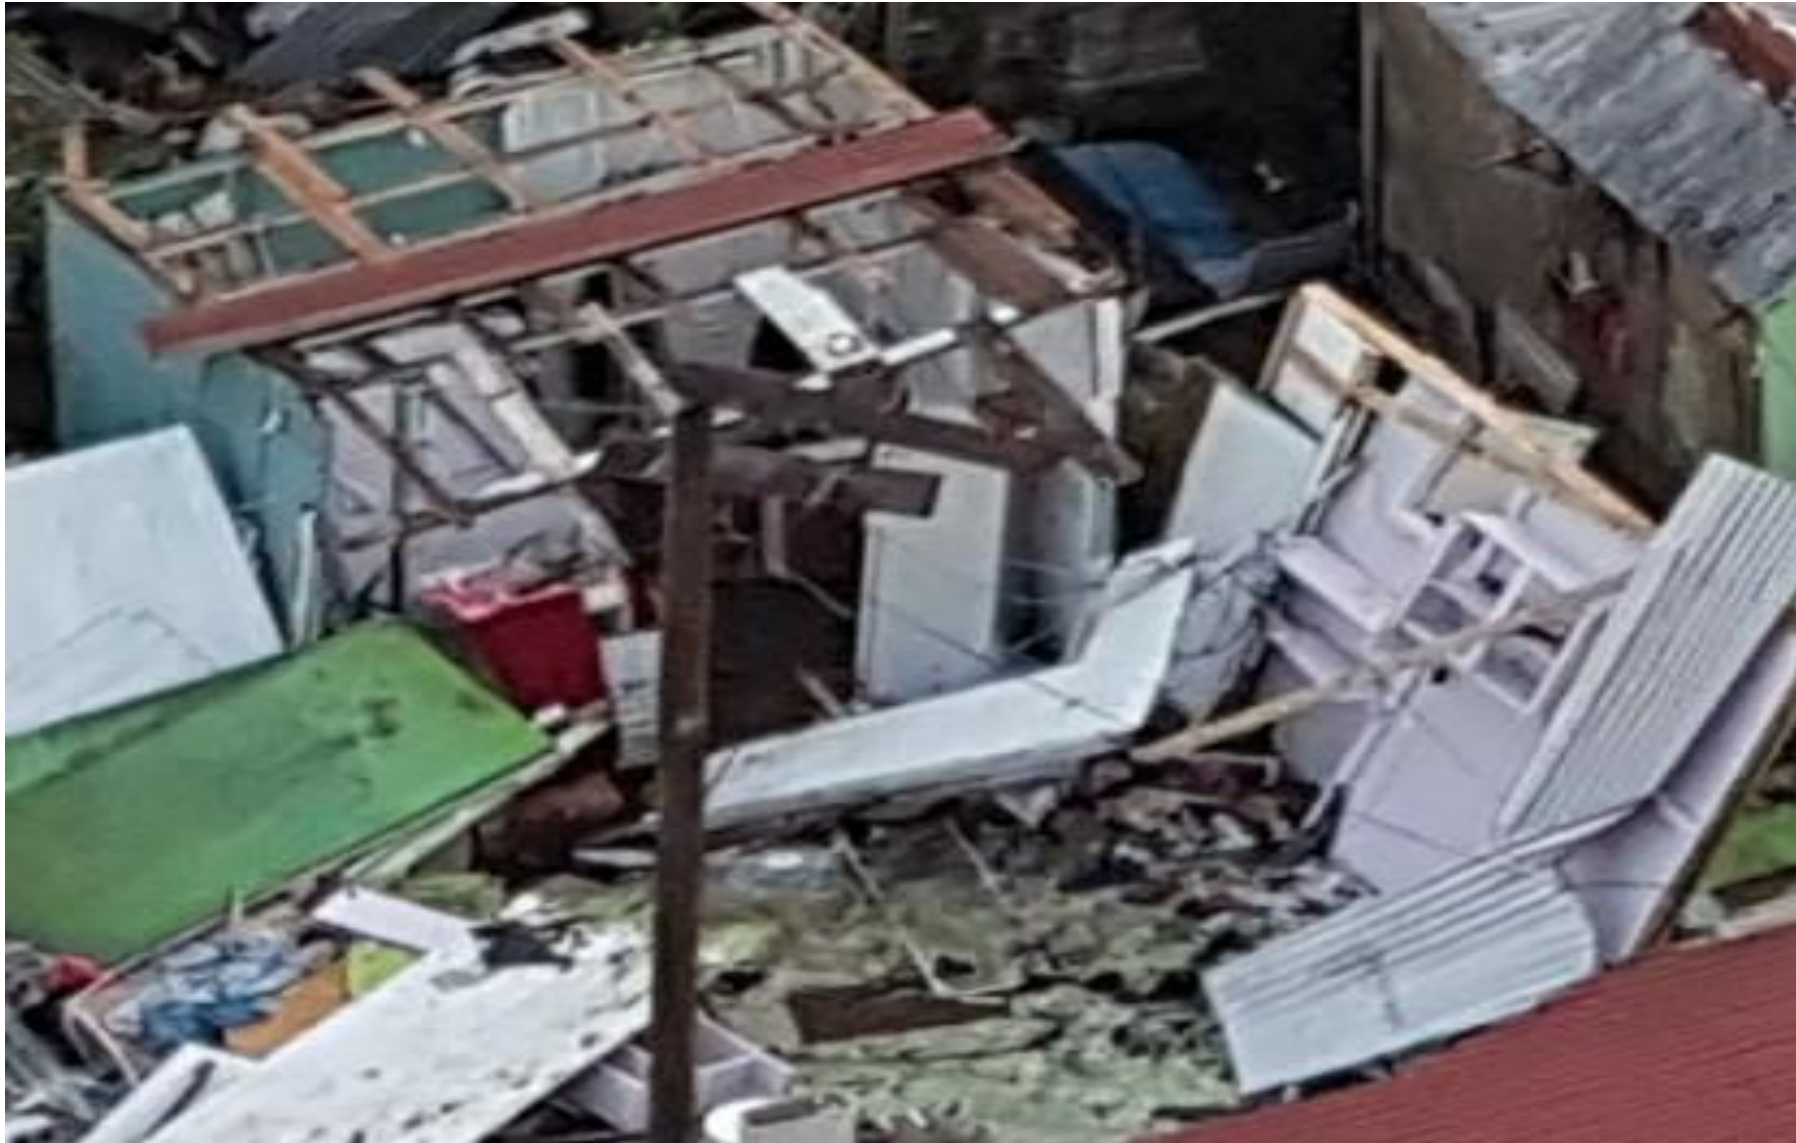
IMAGE 18 –EXAMPLE OF TIMBER OUT-OF-PLANE WALL FAILURE

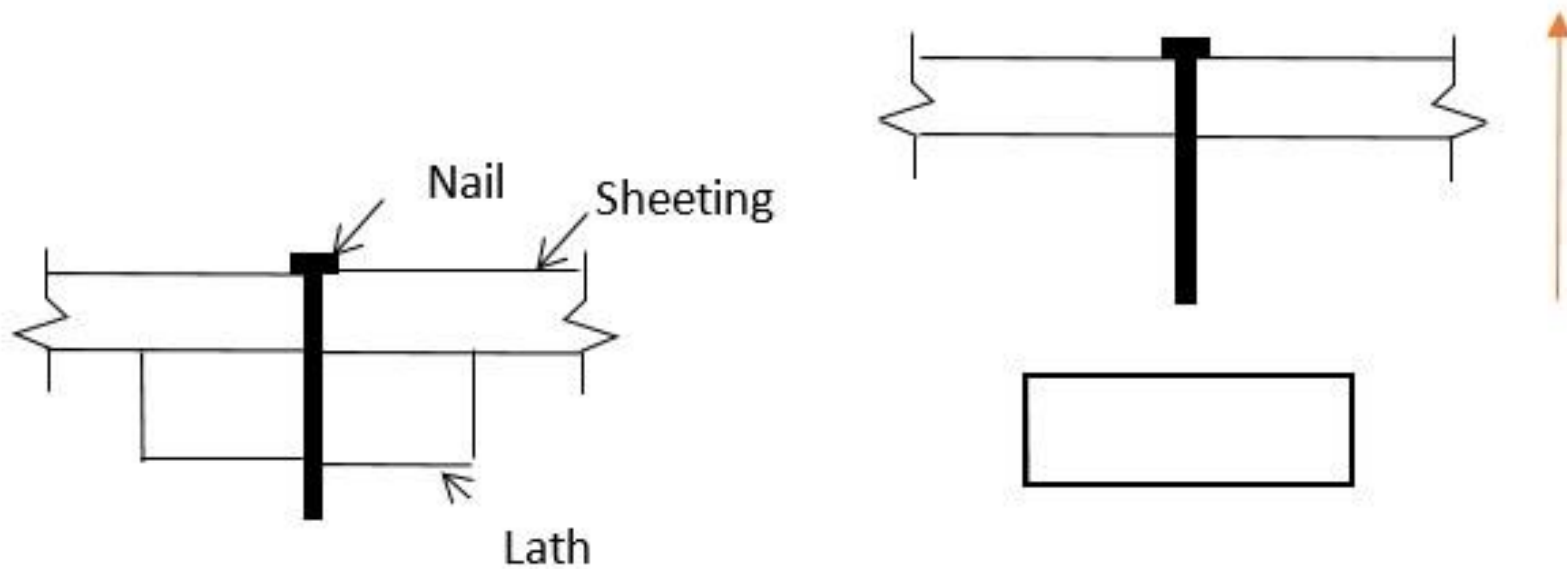
IMAGE 19 – Sheeting-to-Lath Connection

Failure Mode: Nail Pullout

Cause: Insufficient embedment; proper fastener not used; insufficient number of fasteners or inadequate installation

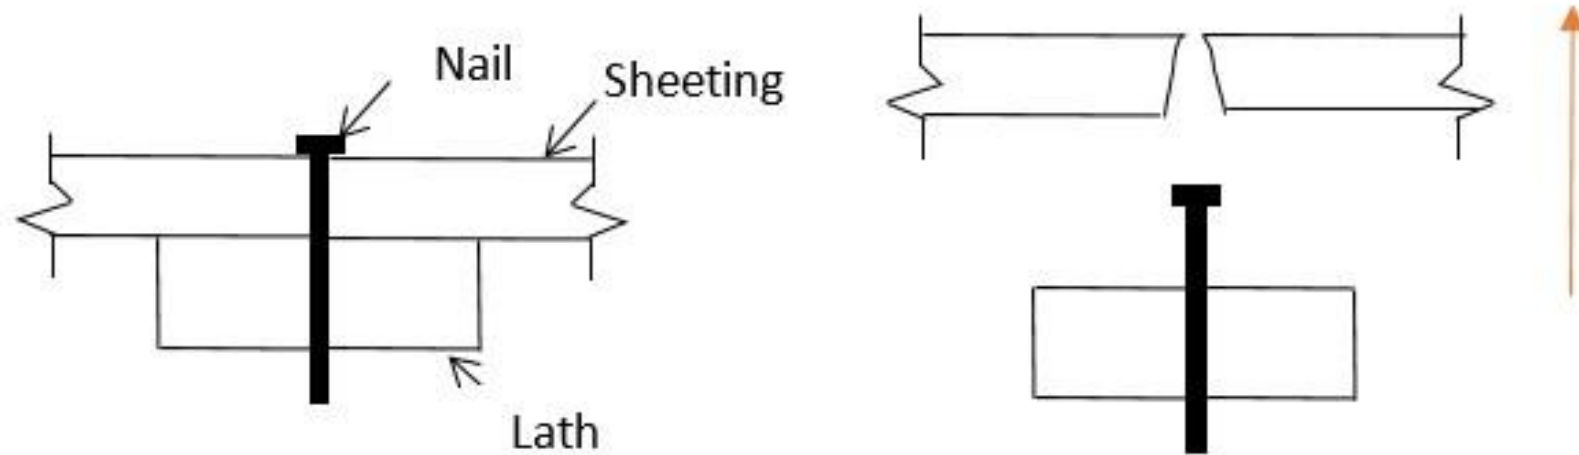
IMAGE 20 – Sheeting-to-Lath Connection

Failure Mode: Sheeting Tear-out

Cause: Sheeting too thin; washers non-existent or too small or too rigid; insufficient number of fasteners or inadequate installation

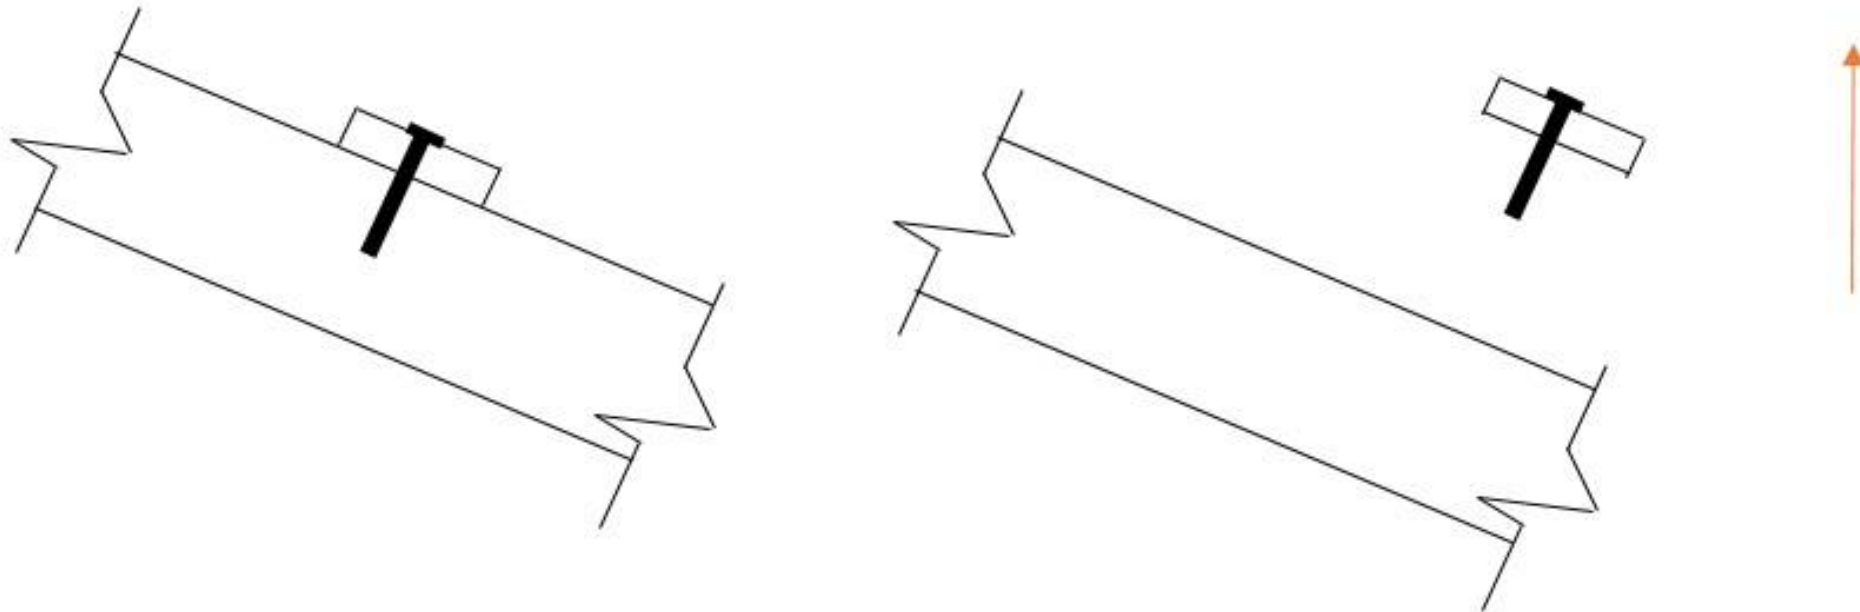
IMAGE 21 – Lath-to-Rafter Connection

Failure Mode: Nail Pullout

Cause: Insufficient embedment or proper strap not used or improperly used.

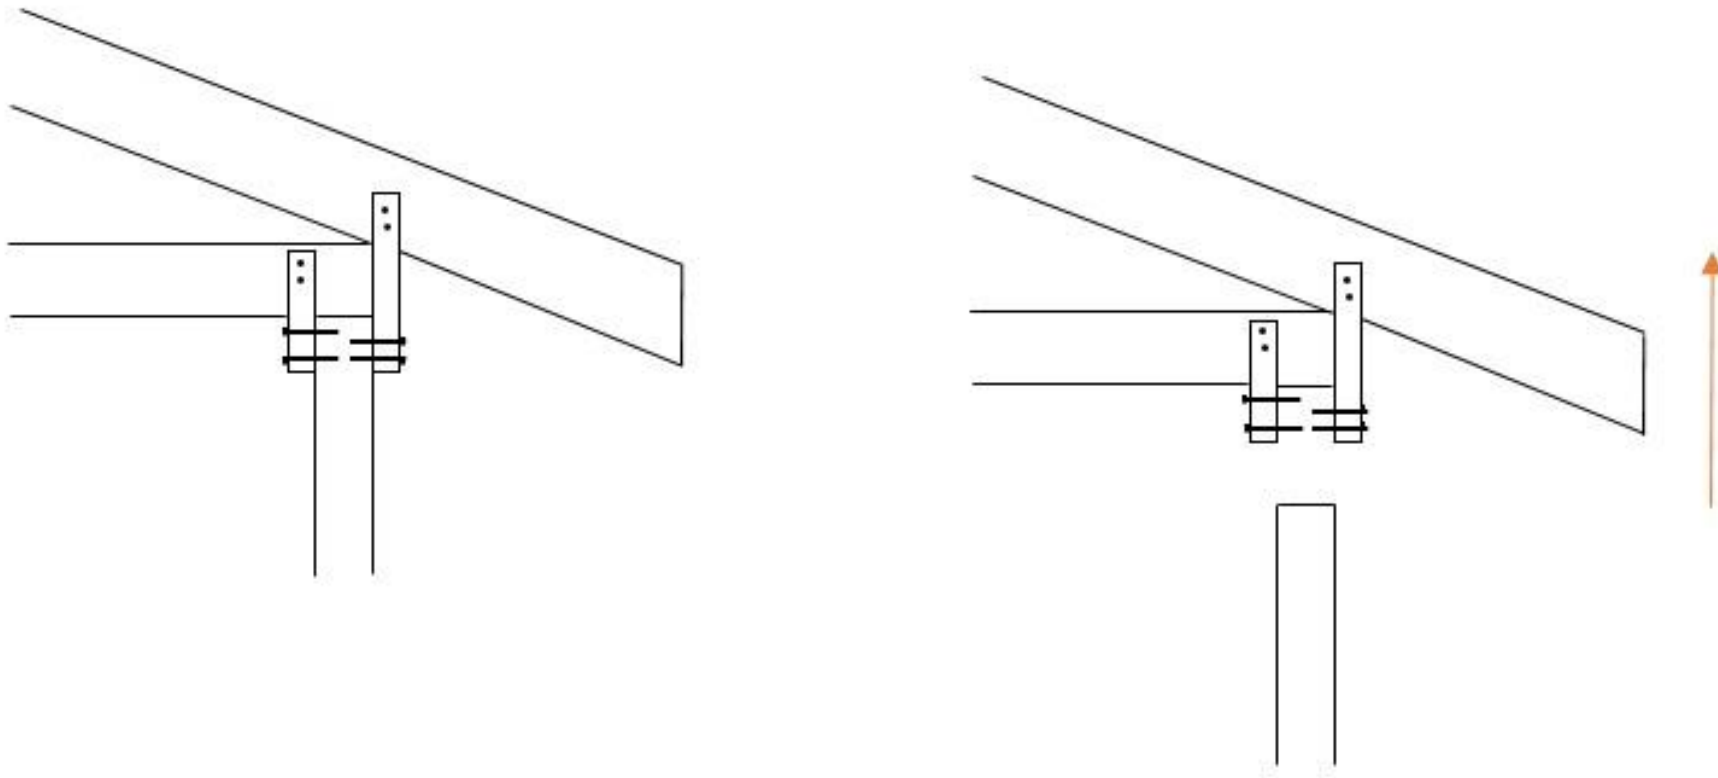
IMAGE 22 – Rafter or Truss-to-Wall Connection

Failure Mode: Assembly Pull-out

Cause: Insufficient tie-down capacity or proper strap not used or improperly used.

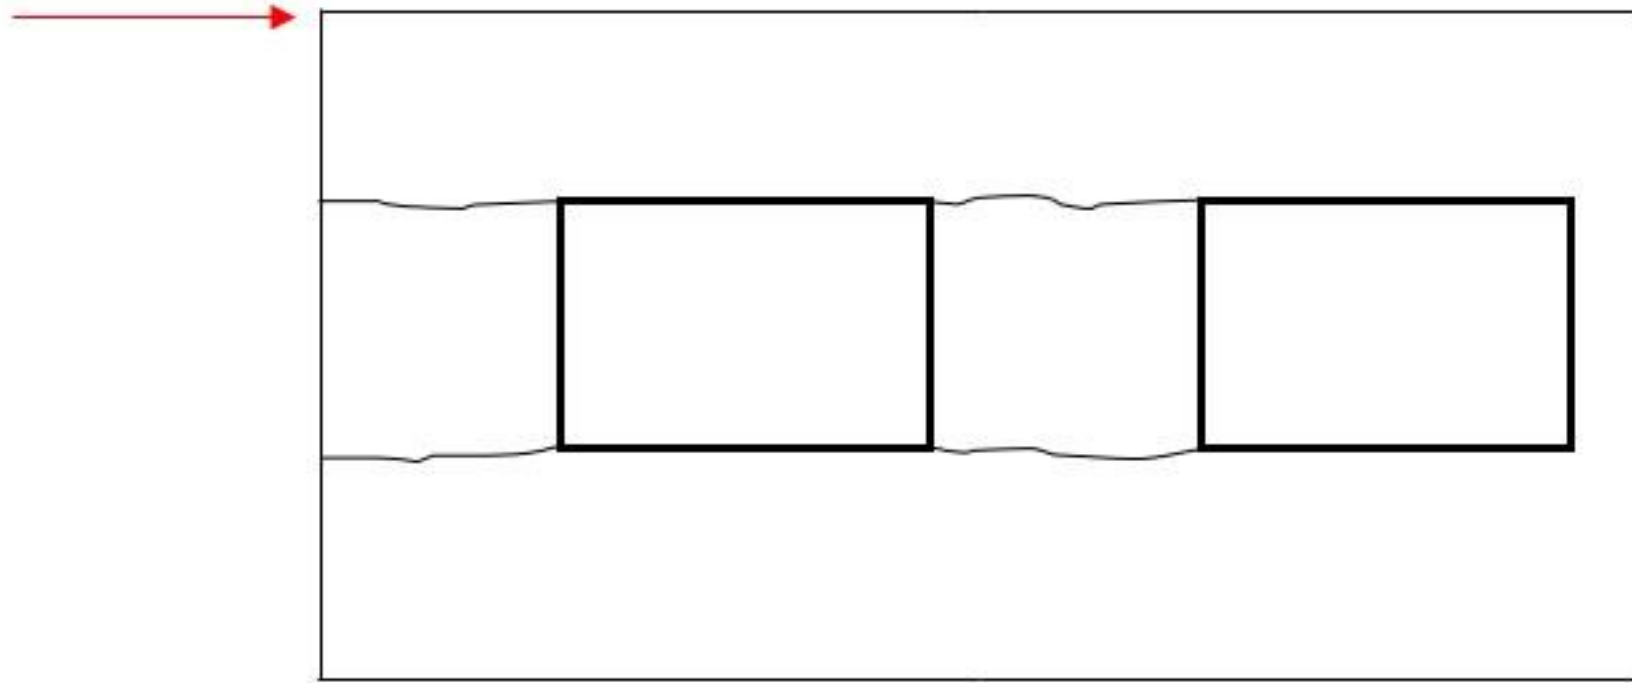
IMAGE 23 – Masonry Wall Piers

Failure Mode: In-plane bending (horizontal top and bottom cracking)

Cause: Insufficient block, joint mortar, or grout compressive strength or, too few rebars or rebar slippage due to inadequate compaction.

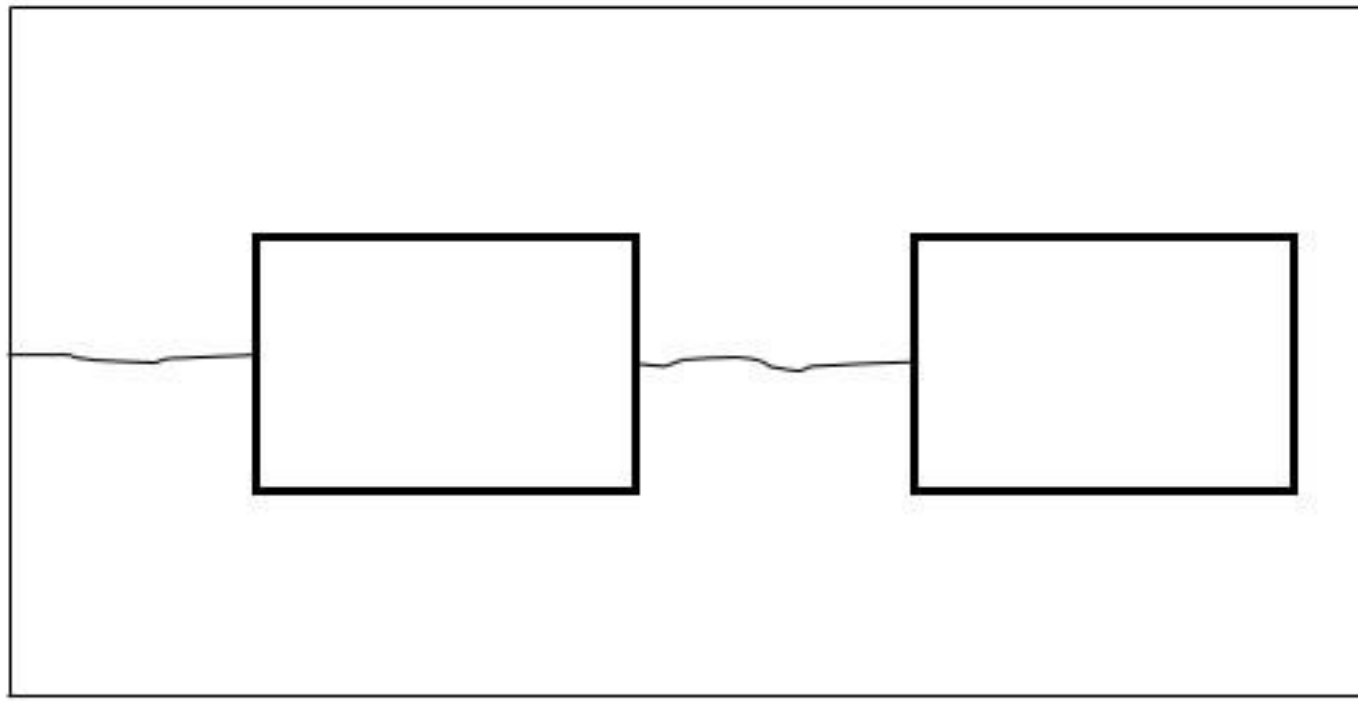
IMAGE 24 – Masonry Wall Piers

Failure Mode: Out-of-plane bending (horizontal mid-span cracking)

Cause: Insufficient block, joint mortar, or grout compressive strength or, too few rebars or rebar slippage due to inadequate compaction.

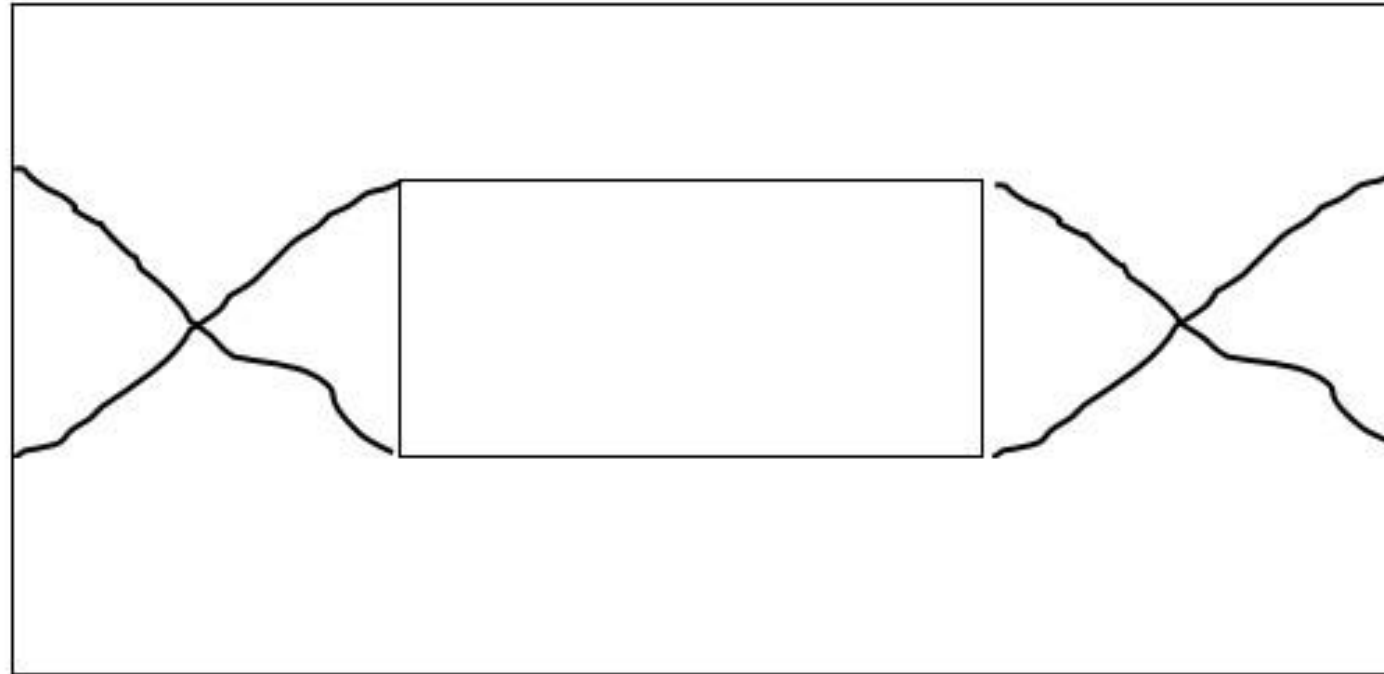
IMAGE 25 – 150 or 200 mm Masonry Wall Piers

Failure Mode: In-plane bending diagonal cracking

Cause: Inadequate horizontal reinforcement; poor unit, joint mortar, and grout compressive strength; possibly excessive vertical rebar.

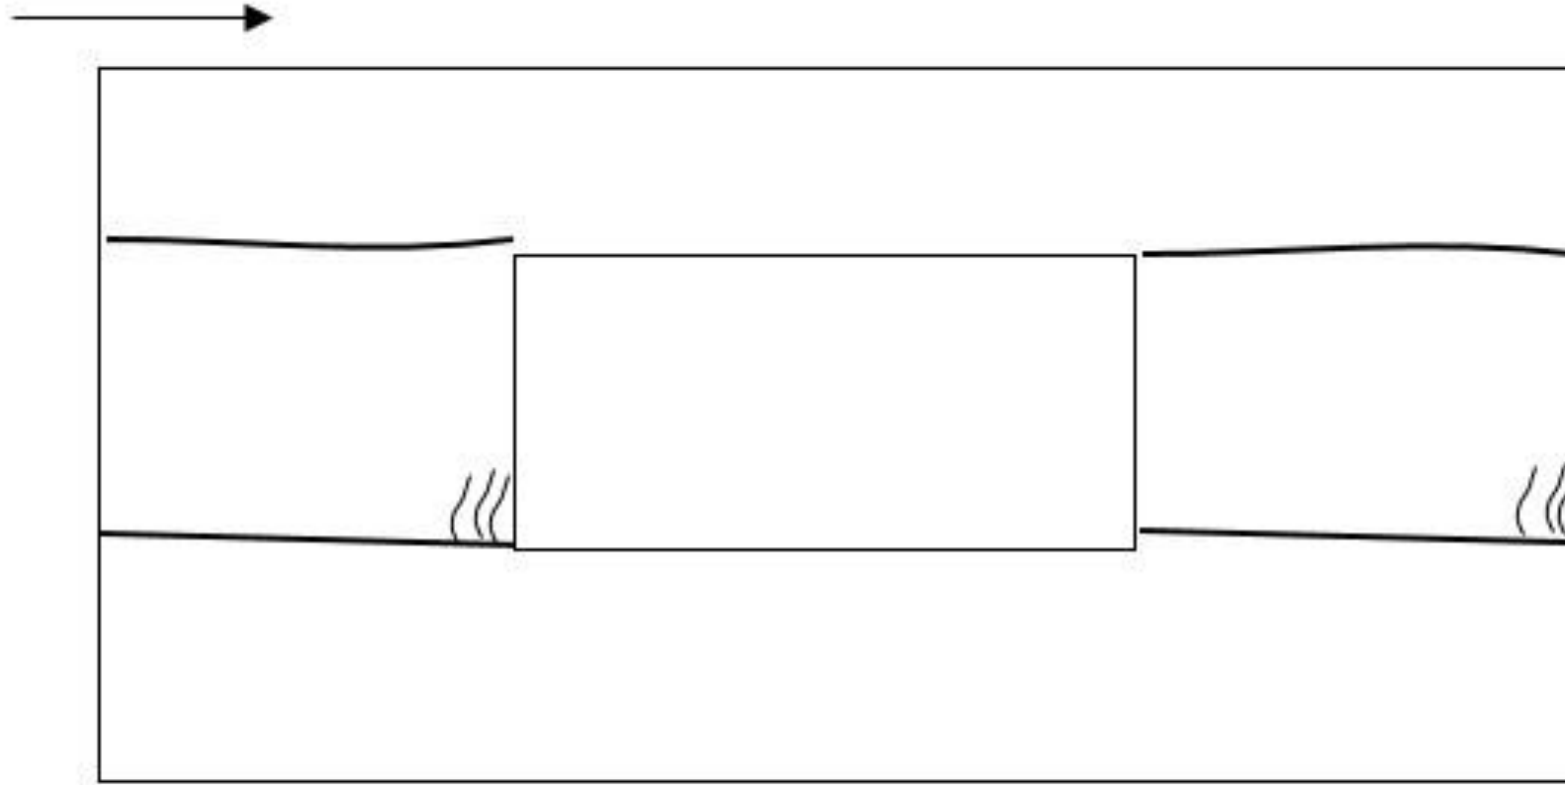
IMAGE 26 – 150 or 200 mm Reinforced Masonry Wall Piers

Failure Mode: In-plane bending vertical toe splitting cracking and top and bottom horizontal cracking

Cause: Inadequate vertical reinforcement; poor unit, joint mortar, and grout compressive strength.

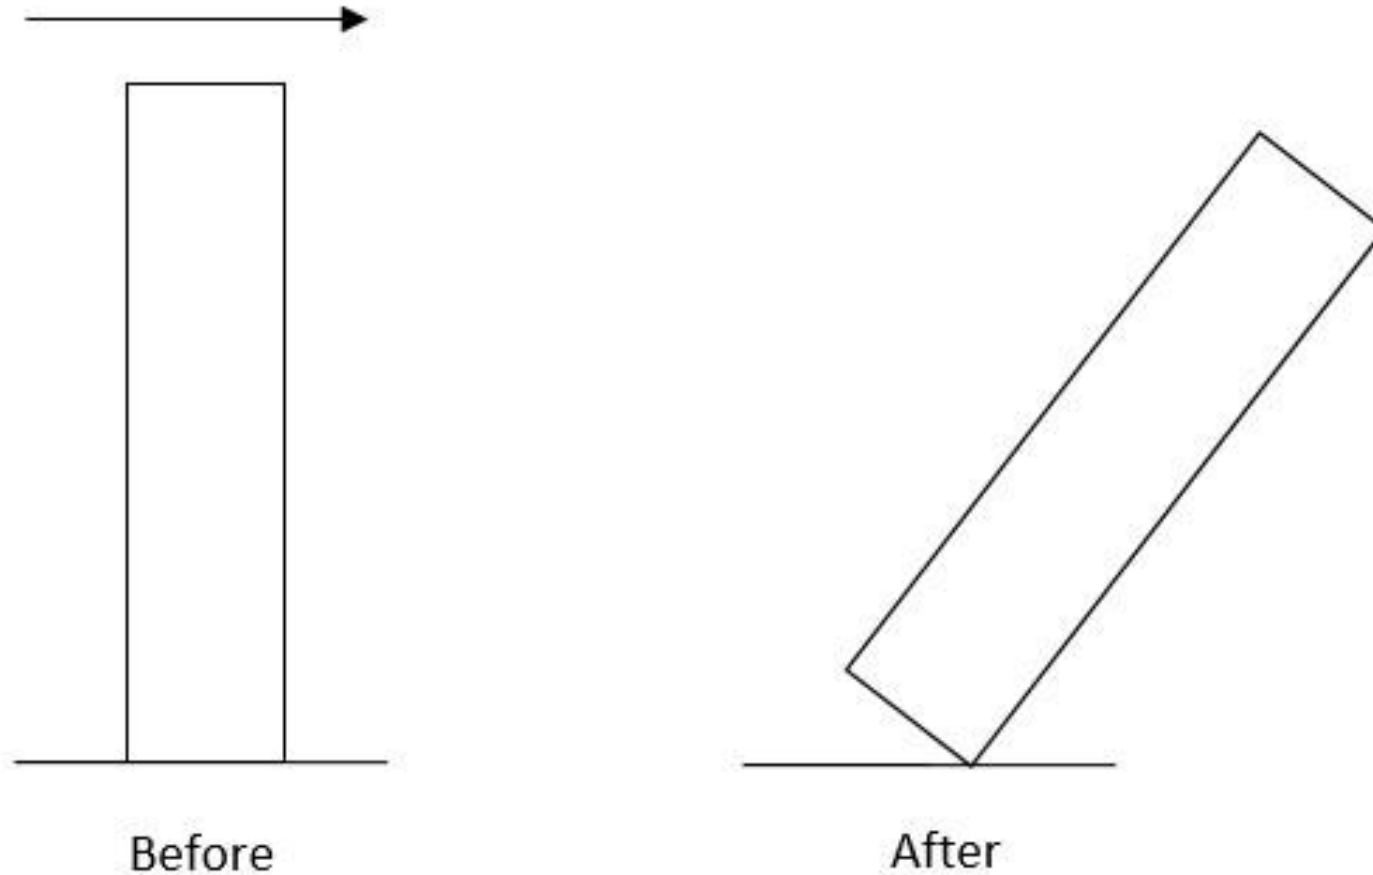
IMAGE 27 – 100 mm Unreinforced Masonry Wall Piers
Failure Mode: Out-of-plane Toppling Instability
Cause: Slenderness too high; bearing stress too low

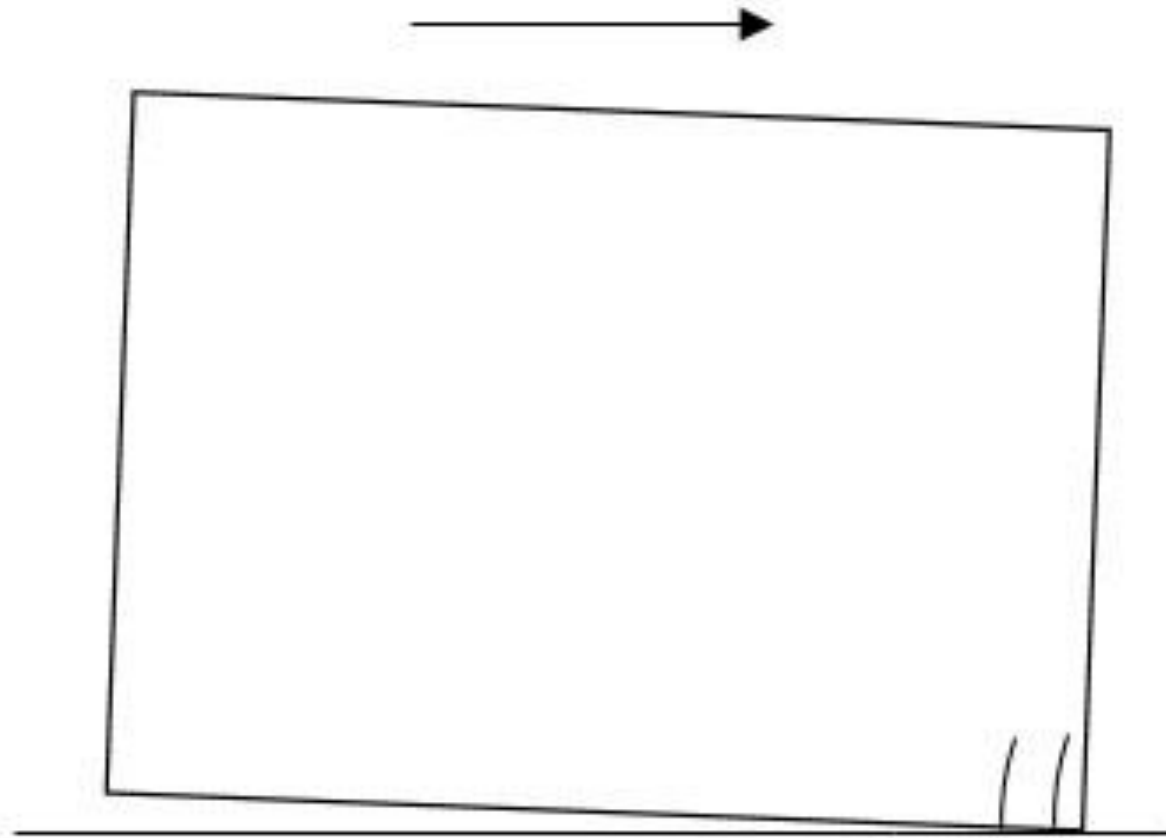
IMAGE 28 – 100 mm Unreinforced Masonry Wall Piers

Failure Mode: In-plane sliding-vertical toe splitting cracking

Cause: Poor unit, or joint mortar, compressive strength; bearing stress too low

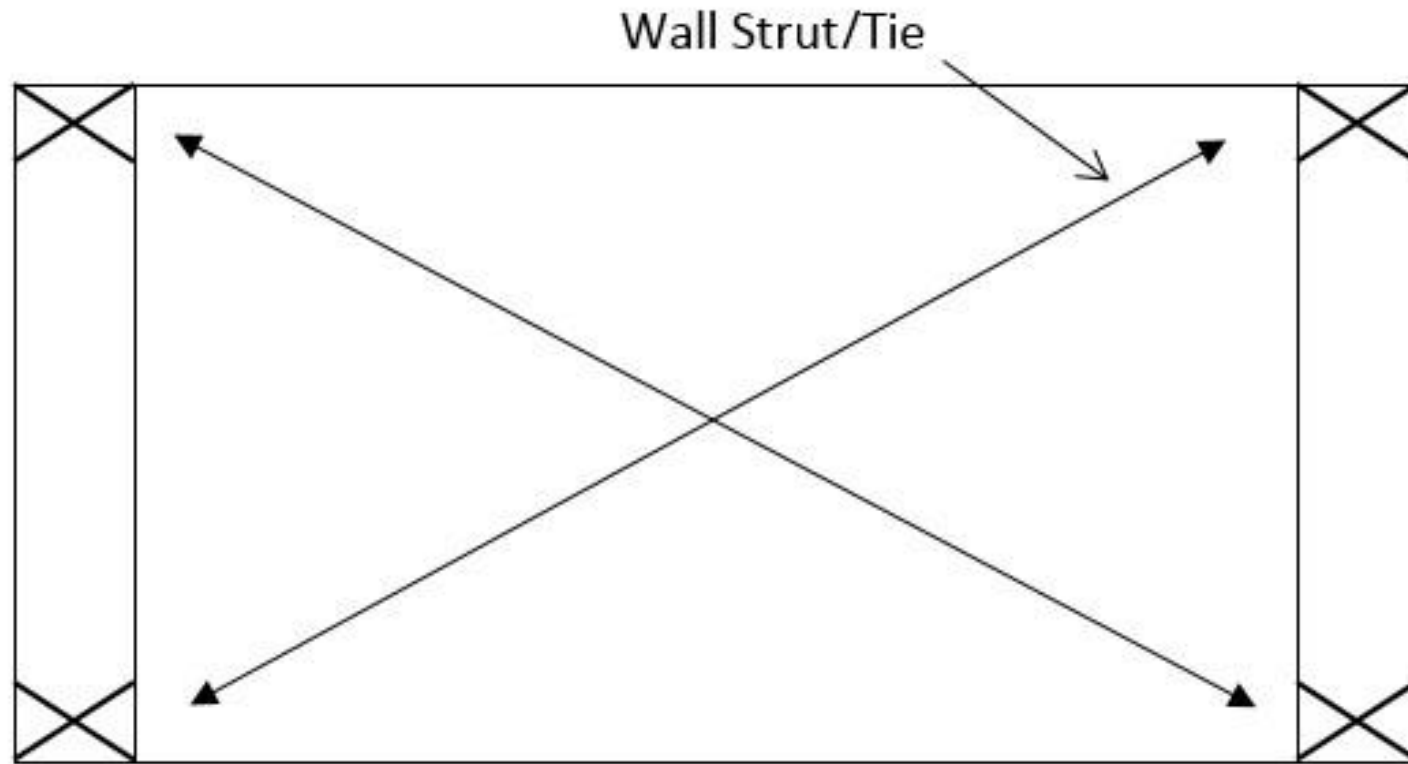
IMAGE 30 – 150 mm RC Masonry Infilled Frame (No Openings)

Failure Mode: Masonry diagonal cracking and RC columns shear failure

Cause of Masonry Failure: Inadequate horizontal reinforcement; poor unit, joint mortar, and grout compressive strength; possibly excessive vertical rebar

Cause of RC Columns failure: Inadequate or insufficient transverse rebar legs

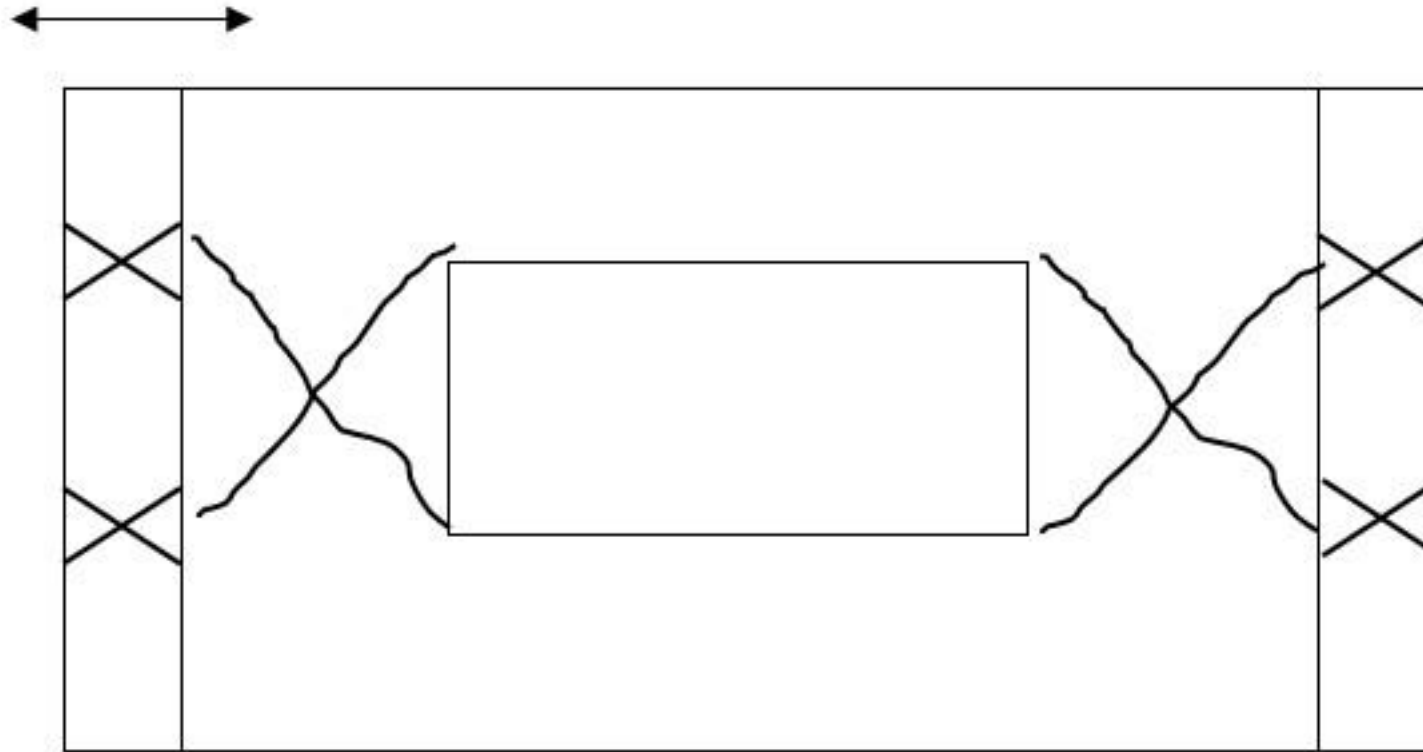
IMAGE 31 – 150 mm RC Masonry Infilled Frame (With Openings)

Failure Mode: Masonry diagonal cracking and RC columns shear failure

Cause of Masonry Failure: Inadequate horizontal reinforcement; poor unit, joint mortar, or grout compressive strength; possibly excessive vertical rebar

Cause of RC Columns failure: Inadequate or insufficient transverse rebar legs
