Hurricane Maria: A Harbinger of Imperative Changes to Caribbean Structural Design and Construction

UNENGINEERED BUILDINGS (HOUSES)

HURRICANE MARIA DAMAGE ASSESSMENT

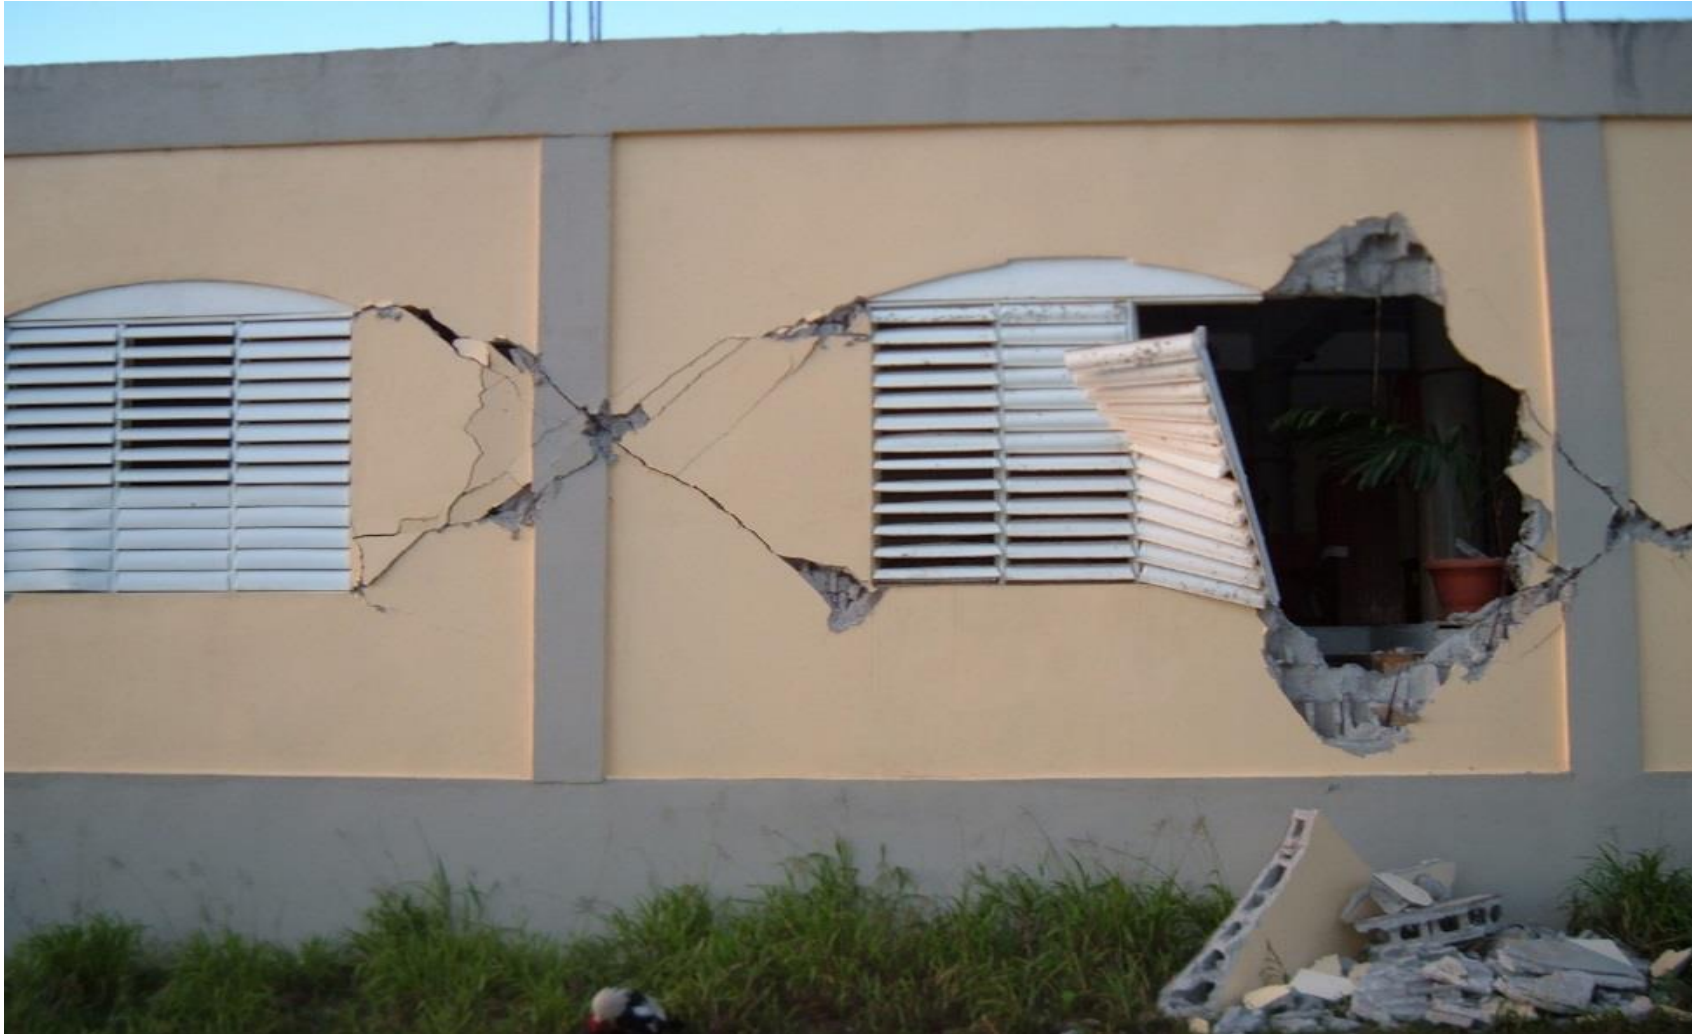
IMAGE 32 – 150 mm RC Masonry Infilled Frame Failure #1 (Dominica Earthquake of 21 November 2004; $M_R = 7.0$, 27 km; Fling-type Motion)

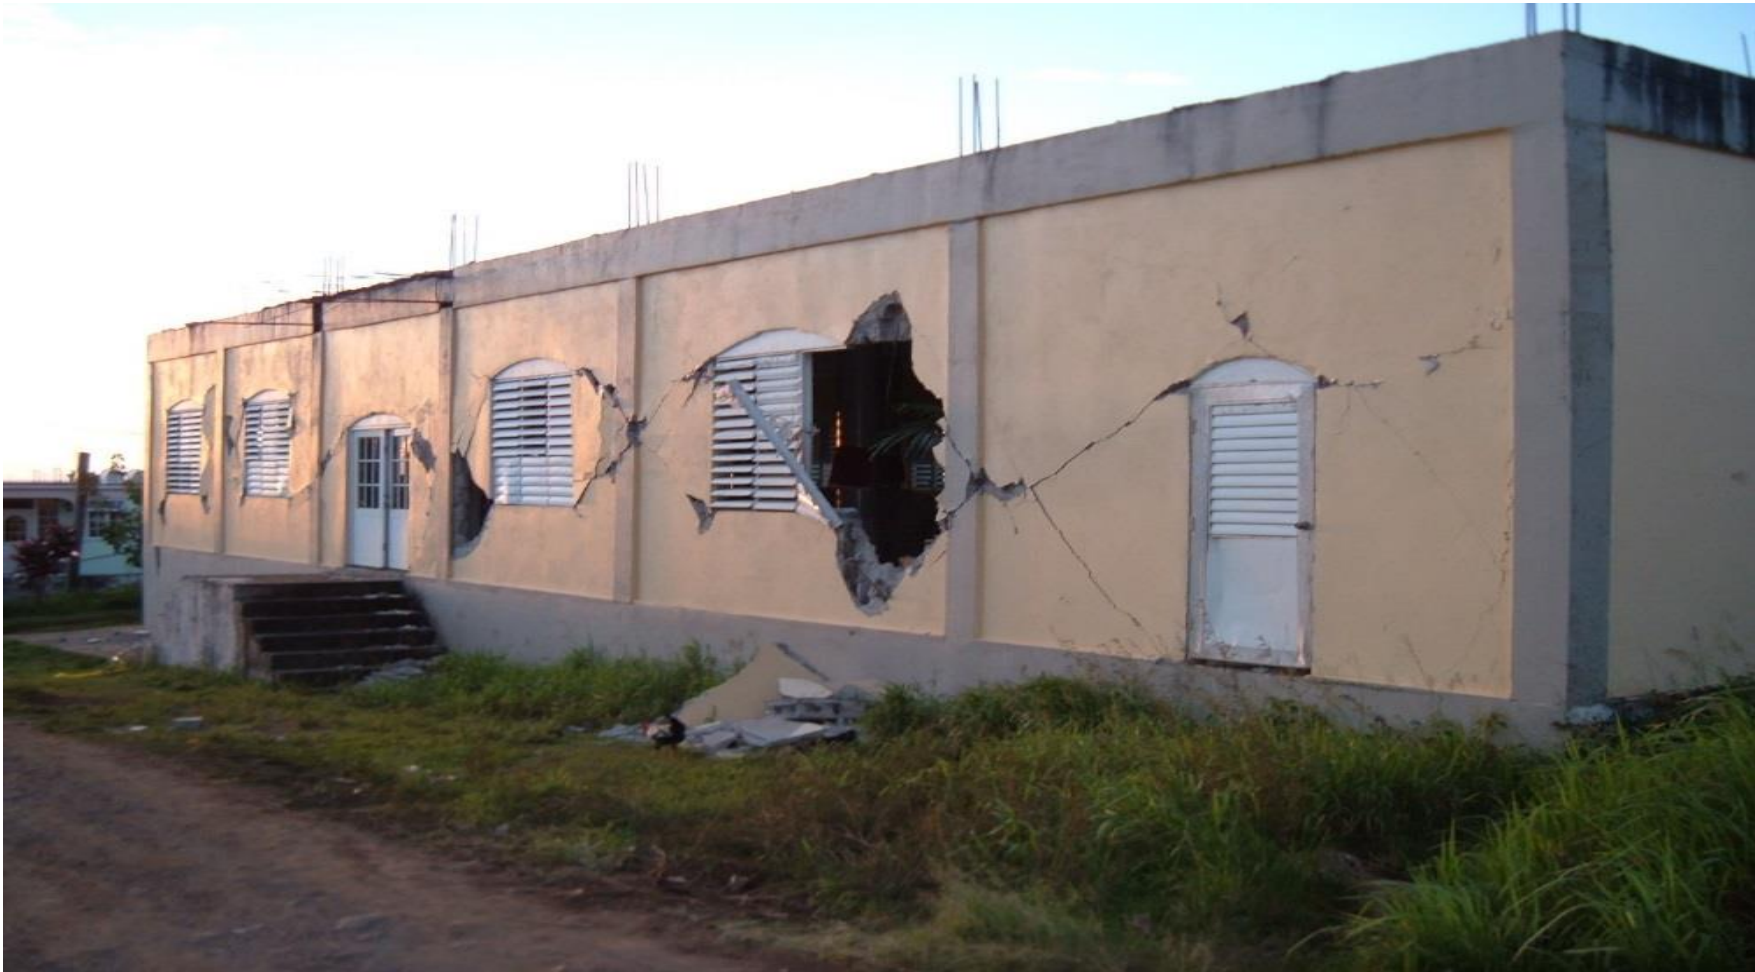
IMAGE 33 – 150 mm RC Masonry Infilled Frame Failure #2 (Dominica Earthquake of 21 November 2004; $M_R = 7.0$, 27 km; Fling-type Motion)

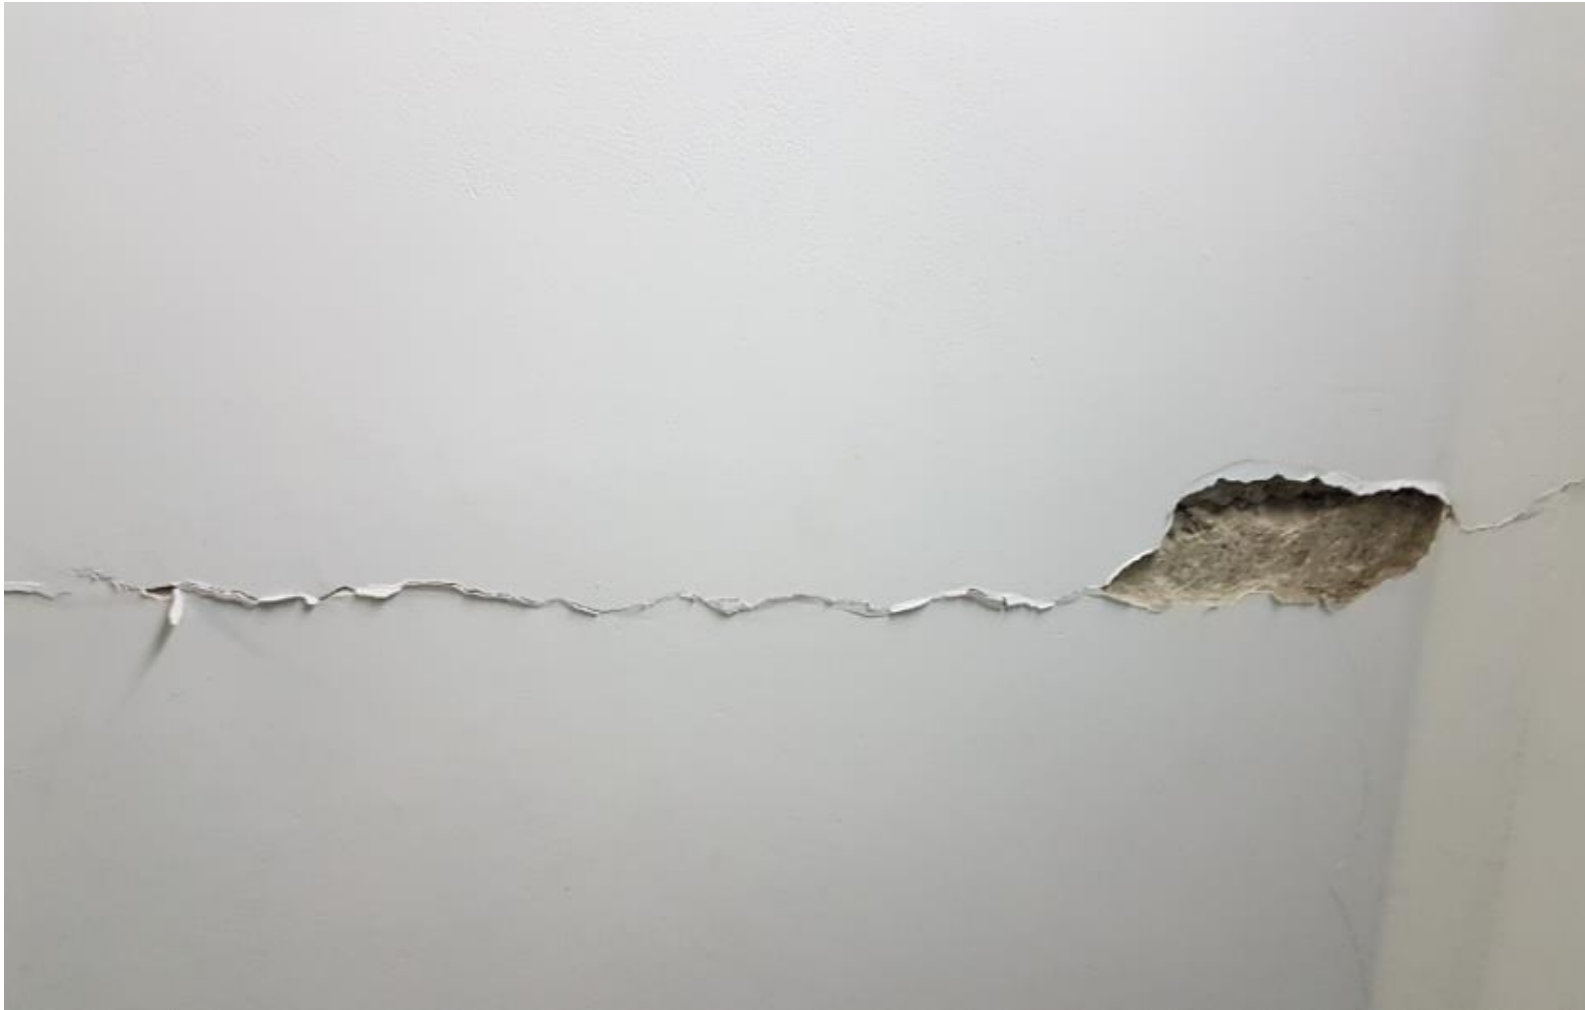
The following photos show the damage that occurred and which was localized in the stair-well area of each floor. There are horizontal cracks along the three segments of each of the stairwell core masonry walls at each storey of the structure. The cracks are located at a level in line with the soffit of the floor beams.

IMAGE 50 - TYPICAL CRACKING OF STAIRWELL CORE WALLS

As stated earlier for the case of unengineered buildings, a FRP or ferrocement overlay can be applied as a retrofit solution for the masonry walls.

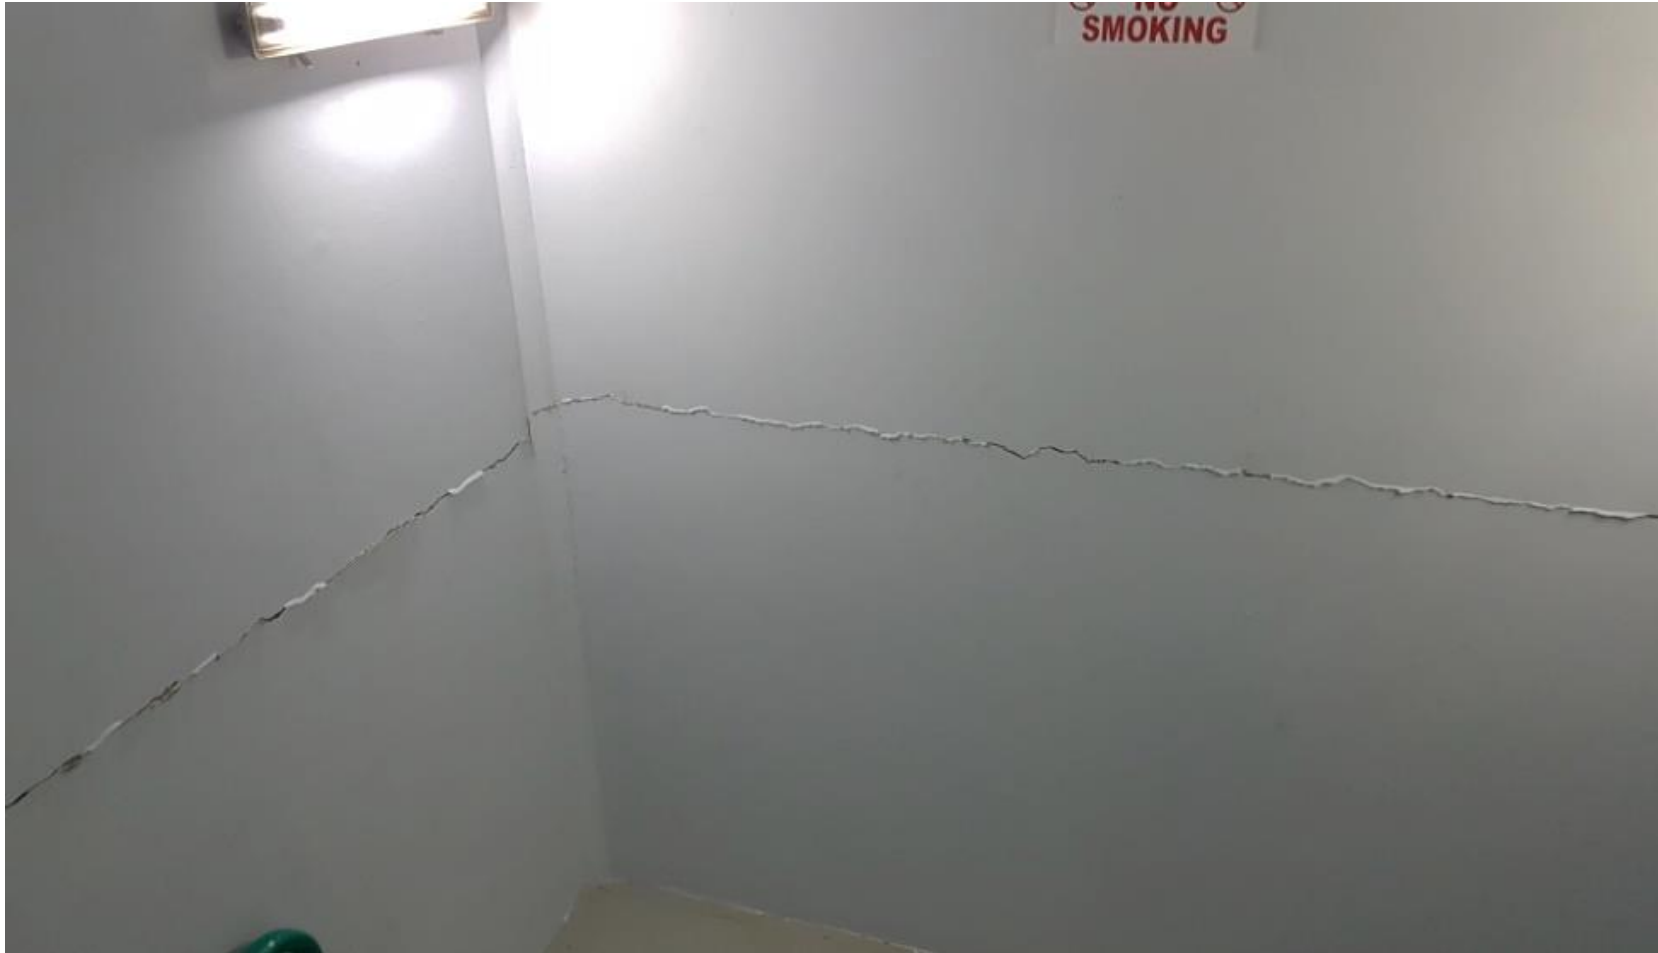
IMAGE 51 - TYPICAL CRACKING OF STAIRWELL CORE WALLS (OTHER SEGMENTS)

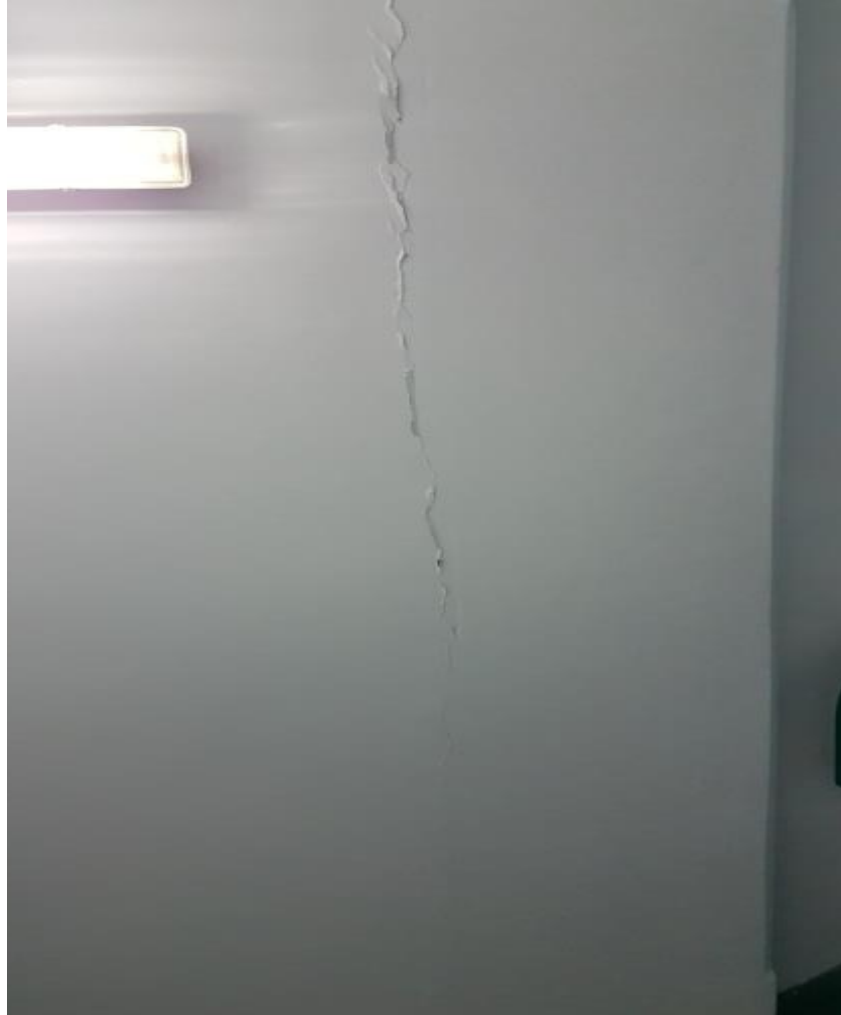
IMAGE 52 - CRACKING AT WALL-COLUMN INTERFACE

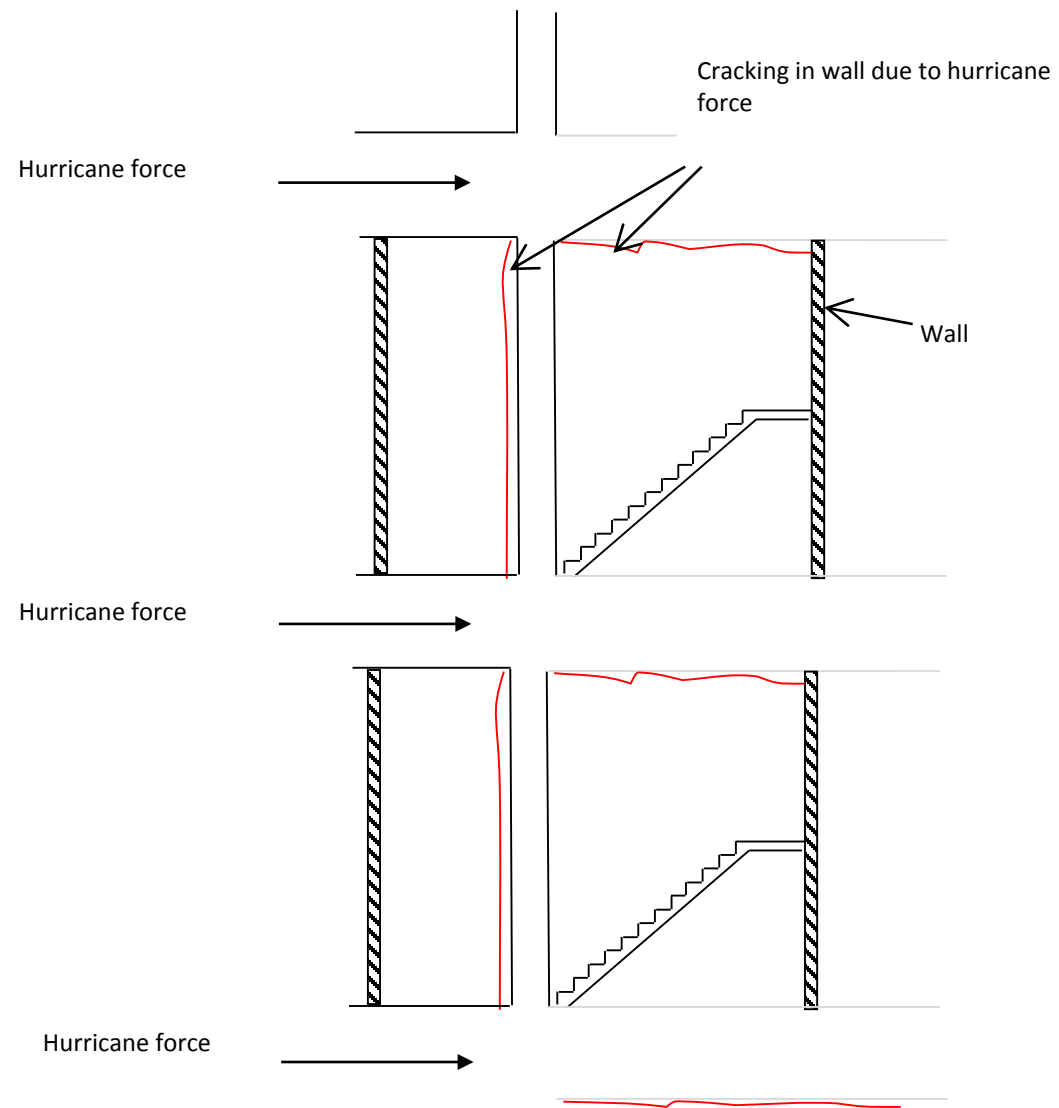
For the previous case, the cause of the cracking is the horizontal force exerted by the hurricane, through the floor slab, and supporting beams. This is shown in the sketch below for two floors. The cracks may also have been initiated by previous hurricane or earthquake events but exacerbated by the present hurricane event. The horizontal force is an in-plane shear force that mobilizes flexural, shear, and axial stresses within the wall that interact with the surrounding frame. In this case, it seems that the interface joint of the wall with the frame forms a weak plane so the cracking takes place at those locations.

IMAGE 53 – CRACK FORMATION IN IN-FILLED MASONRY WALLS

The cracked walls probably do not impair the present ability of the structure to address future hurricanes in terms of the overall building performance though this should be verified by further analysis.

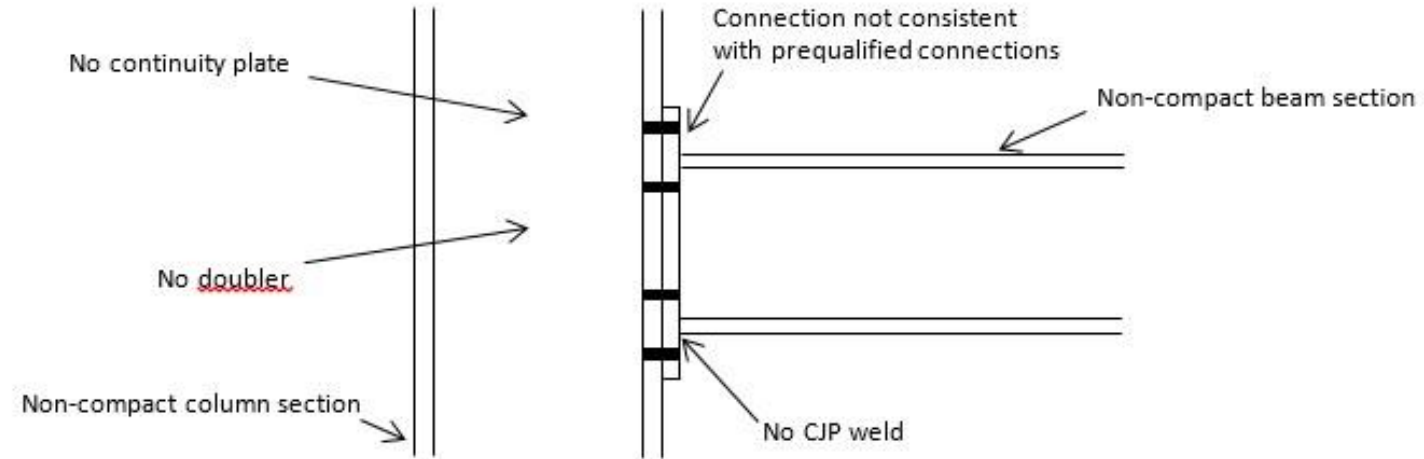
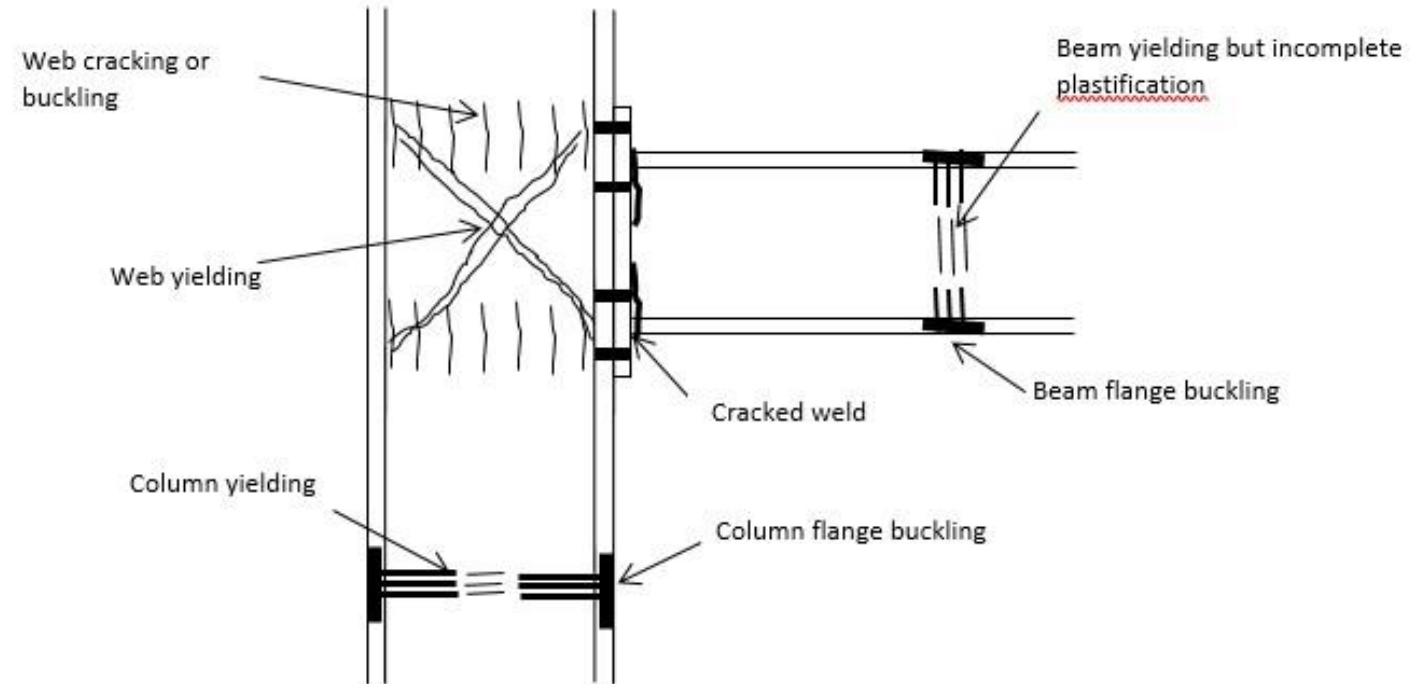
IMAGE 55 – Typical frame in column major axis direction
 Failure Modes: Panel zone shear or tension yielding or buckling; connection weld cracking; beam yielding or column yielding; beam or column local buckling
 Causes: Column web too thin or material too weak; weld too weak; incomplete beam plastification due to slab interaction or excessive unsupported length; beam or column flanges or web too thin

For frames in the major-axis direction:

- i. Beams and columns can be strengthened by adding external steel cover plates
- ii. Bolt forces can be reduced by adding haunches to the ends of beams

- iii. Panel zones can be retrofitted by adding doubler plates by extending the end plates of beams transverse to the joint, and adding continuity plates
